**Flood Control Project Maintenance
Levee Inspections
LMA District Cover Sheet
Spring 2010 Levee Inspection Results**

Reclamation District No. 2095 Paradise Cut

Waterway			Bank	Unit Miles
Unit No. 01 Paradise Cut			Left	1.45
	Spring (March - May)	Summer (June - August)	(September - November) Fall	Winter (December - February)
Unit Maintenance Rating (Fall Only)				
Date of Inspection	5/13/2010 - 5/13/2010			
DWR Inspector	John Paasch			
Accompanied By	Rosie Silva RD 2095

Levee Inspection Report By Mile - Spring 2010

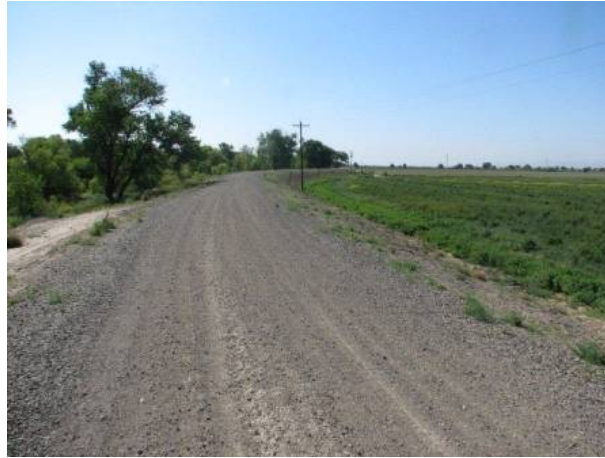
Levee Mile Report Line	1
Start Levee Mile	0.13
End Levee Mile	0.35
Location	Land Side
Category	Earthen Levee
Item	Vegetation

Control annual grasses within 10' of levee toe.

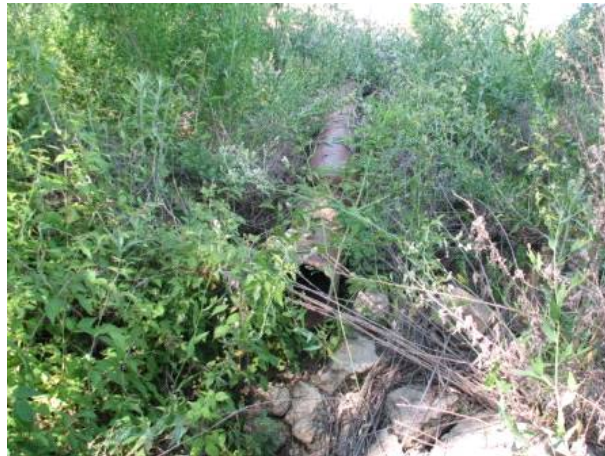
Levee Mile Report Line	3
Start Levee Mile	0.35
End Levee Mile	0.35
Location	Crown
Category	Earthen Levee
Item	Encroachments

Drainage discharge into San Joaquin River.

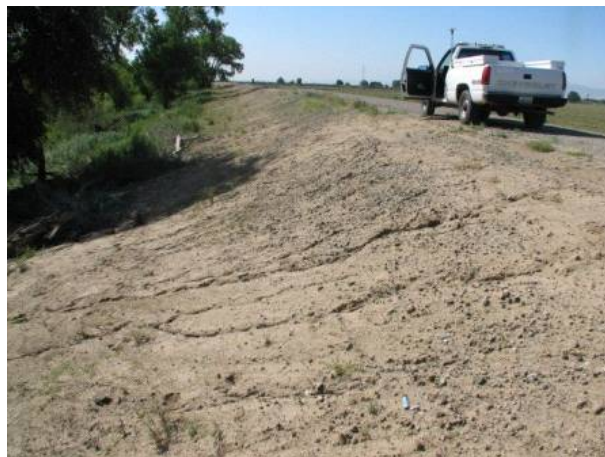
Levee Mile Report Line	4
Start Levee Mile	0.41
End Levee Mile	0.41
Location	Water Side
Category	Earthen Levee
Item	Erosion / Bank Caving

Runoff has begun to erode levee slope.

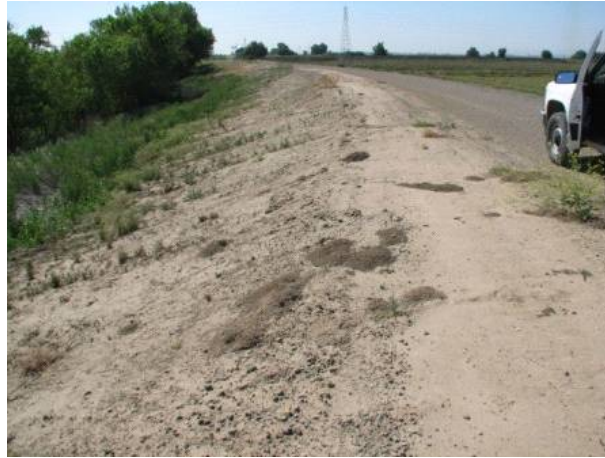
Levee Mile Report Line	5
Start Levee Mile	0.54
End Levee Mile	0.54
Location	Water Side
Category	Earthen Levee
Item	Animal Control

Animal burrows on levee slope and crown.

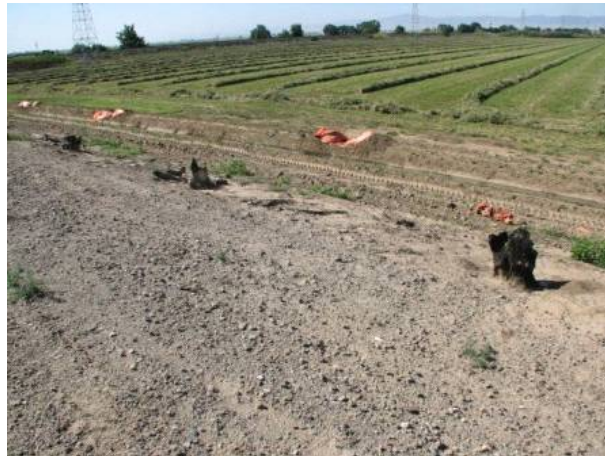
Levee Mile Report Line	6
Start Levee Mile	0.63
End Levee Mile	0.63
Location	Land Side
Category	Earthen Levee
Item	Trim / Thin Trees

Tree trunks along levee slope.

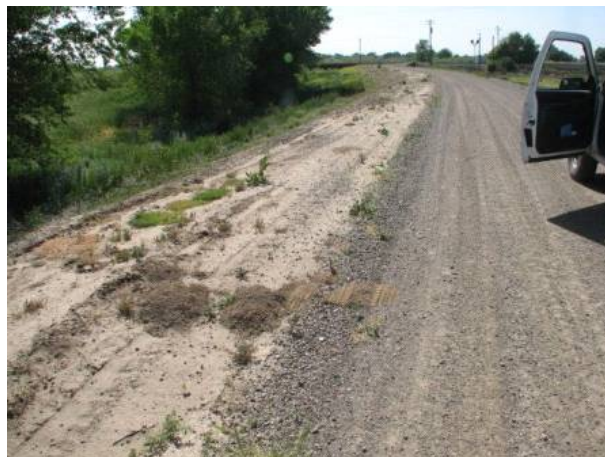
Levee Mile Report Line	7
Start Levee Mile	0.63
End Levee Mile	0.63
Location	Crown
Category	Earthen Levee
Item	Animal Control

Animal burrows on levee slope and crown.

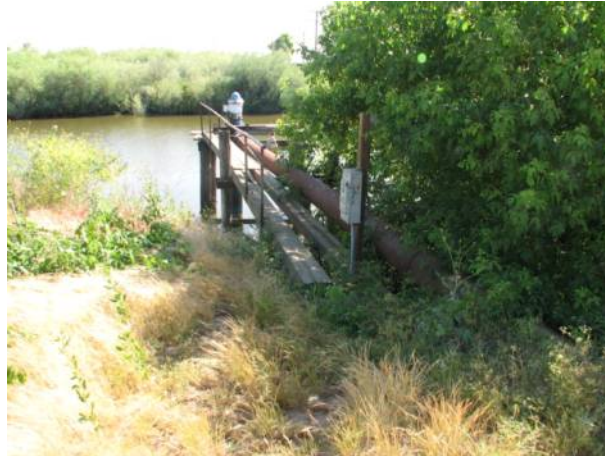
Levee Mile Report Line	8
Start Levee Mile	0.70
End Levee Mile	0.70
Location	Water Side
Category	Earthen Levee
Item	Encroachments
Irrigation intake penetrates levee freeboard. Vegetation limits access to platform.	
jpaasch_s_20100514_415.jpg

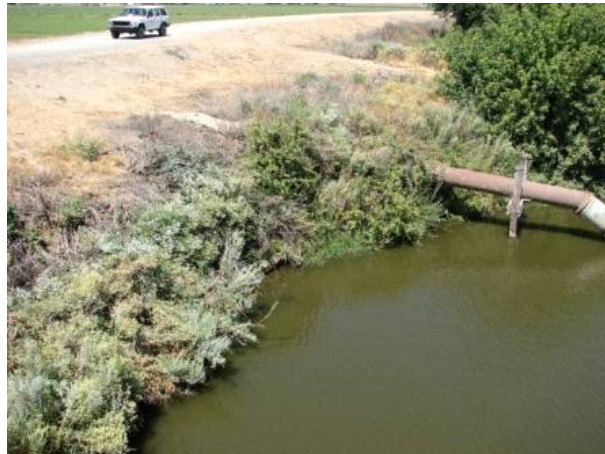
Levee Mile Report Line	10
Start Levee Mile	0.73
End Levee Mile	0.74
Location	Water Side
Category	Supplemental
Item	DWR Erosion Survey
2009:No major change noticeable, vegetation growth; erosion is on berm, but if left untreated, it will eventually erode into levee prism; recommend annual assessment/monitoring of site, per CES 2008 Report;site # same as RM6.8,LM0.73; previously rated "U" [2009 SiteID:RD2095U1RM6.74]	
SJR2009_RM6.74U1 072709A.jpg

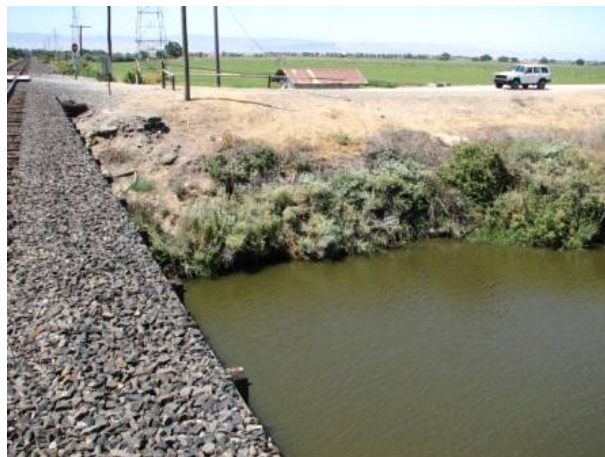
Levee Mile Report Line	10
Start Levee Mile	0.73
End Levee Mile	0.74
Location	Water Side
Category	Supplemental
Item	DWR Erosion Survey
2009:No major change noticeable, vegetation growth; erosion is on berm, but if left untreated, it will eventually erode into levee prism; recommend annual assessment/monitoring of site, per CES 2008 Report;site # same as RM6.8,LM0.73; previously rated "U" [2009 SiteID:RD2095U1RM6.74]	
SJR2009_RM6.74U1 072709C.jpg

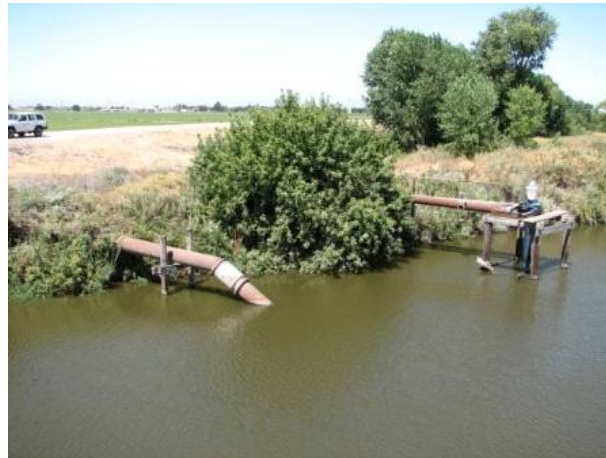
Levee Mile Report Line	10
Start Levee Mile	0.73
End Levee Mile	0.74
Location	Water Side
Category	Supplemental
Item	DWR Erosion Survey

2009: No major change noticeable, vegetation growth; erosion is on berm, but if left untreated, it will eventually erode into levee prism; recommend annual assessment/monitoring of site, per CES 2008 Report; site # same as RM6.8, LM0.73; previously rated "U" [2009 SiteID:RD2095U1RM6.74]

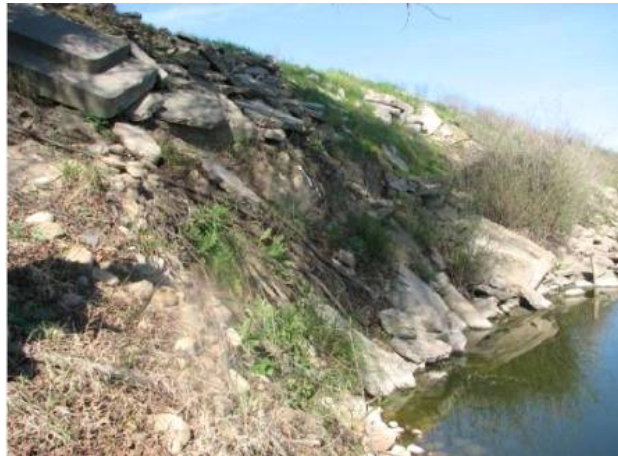
Levee Mile Report Line	14
Start Levee Mile	0.86
End Levee Mile	0.86
Location	Water Side
Category	Supplemental
Item	DWR Erosion Survey

2009: No major change observed; near-vertical slope that has rip rap sloughing; recommend as a local maintenance issue, per CLRO CES Evaluation 2008 Report; site# same as RM6.9, LM0.86; previously rated "U" [2009 SiteID:RD2095U1RM6.88]

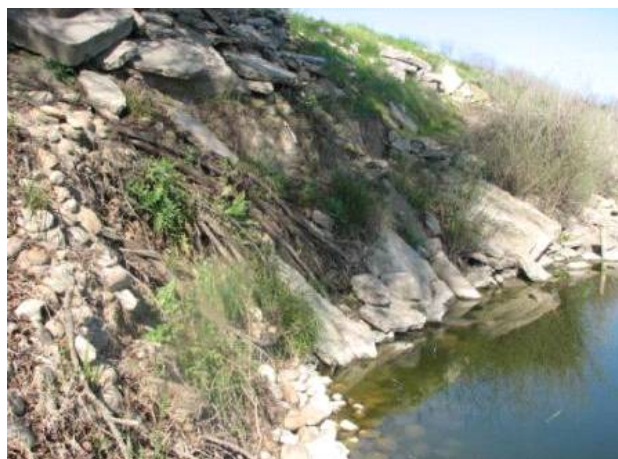
Levee Mile Report Line	14
Start Levee Mile	0.86
End Levee Mile	0.86
Location	Water Side
Category	Supplemental
Item	DWR Erosion Survey

2009: No major change observed; near-vertical slope that has rip rap sloughing; recommend as a local maintenance issue, per CLRO CES Evaluation 2008 Report; site# same as RM6.9, LM0.86; previously rated "U" [2009 SiteID:RD2095U1RM6.88]

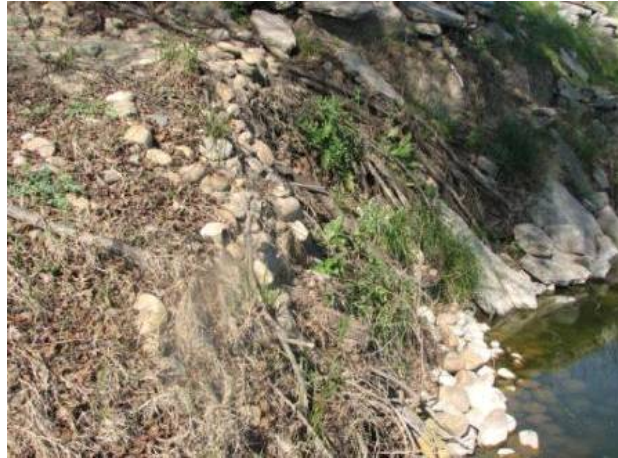
Levee Mile Report Line	14
Start Levee Mile	0.86
End Levee Mile	0.86
Location	Water Side
Category	Supplemental
Item	DWR Erosion Survey

2009: No major change observed; near-vertical slope that has rip rap sloughing; recommend as a local maintenance issue, per CLRO CES Evaluation 2008 Report; site# same as RM6.9,LM0.86; previously rated "U" [2009 SiteID:RD2095U1RM6.88]

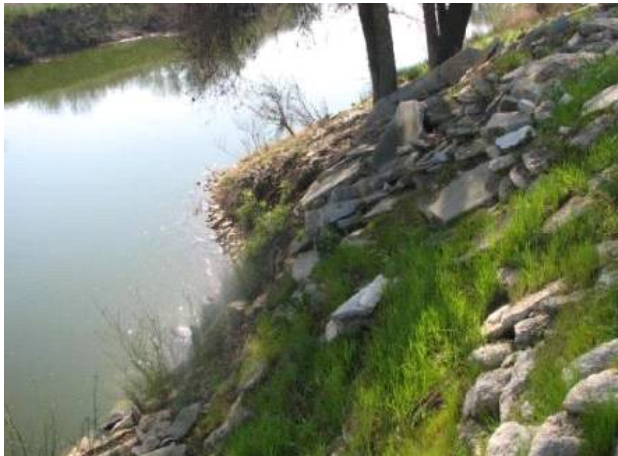
Levee Mile Report Line	14
Start Levee Mile	0.86
End Levee Mile	0.86
Location	Water Side
Category	Supplemental
Item	DWR Erosion Survey

2009: No major change observed; near-vertical slope that has rip rap sloughing; recommend as a local maintenance issue, per CLRO CES Evaluation 2008 Report; site# same as RM6.9,LM0.86; previously rated "U" [2009 SiteID:RD2095U1RM6.88]

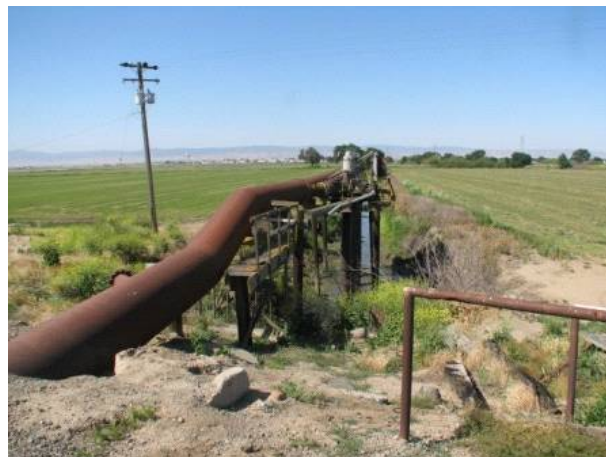
Levee Mile Report Line	15
Start Levee Mile	0.88
End Levee Mile	0.88
Location	Land Side
Category	Earthen Levee
Item	Encroachments

Large pump platform for drainage into San Joaquin River. No positive closure devices. Pipe penetrates levee freeboard. No flap gate at outlet.

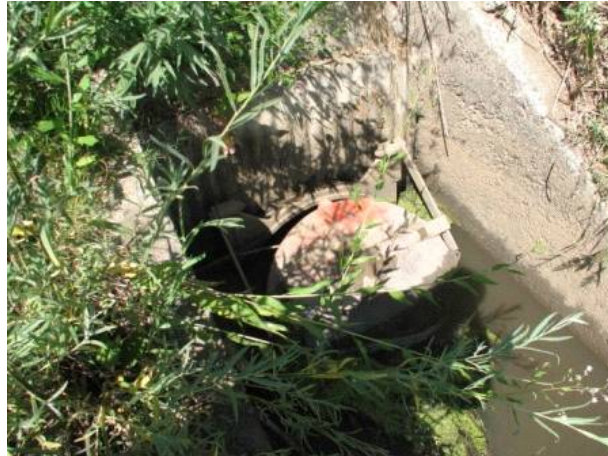
Levee Mile Report Line	16
Start Levee Mile	0.88
End Levee Mile	0.88
Location	Water Side
Category	Earthen Levee
Item	Encroachments

Gravity drainage outlet flapgate blocked by debris.

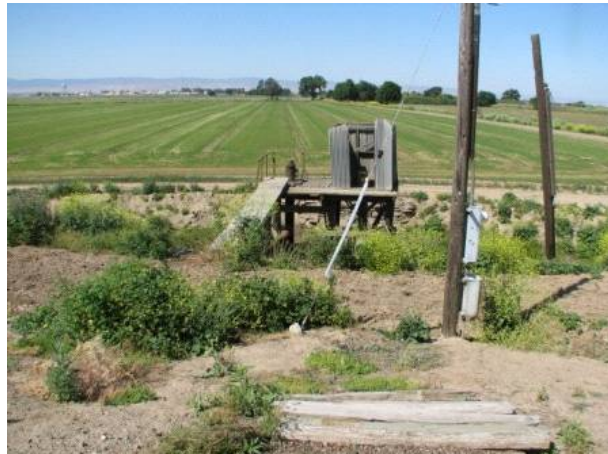
Levee Mile Report Line	17
Start Levee Mile	0.92
End Levee Mile	0.92
Location	Land Side
Category	Earthen Levee
Item	Encroachments

Two pumps on platform. Two pipes cross levee.

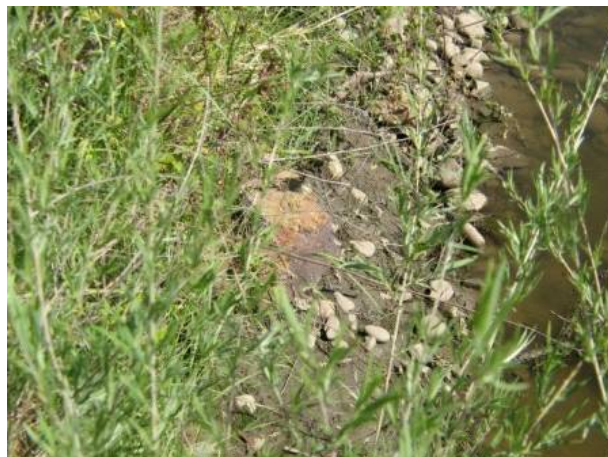
Levee Mile Report Line	17
Start Levee Mile	0.92
End Levee Mile	0.92
Location	Land Side
Category	Earthen Levee
Item	Encroachments

Pipe outlet to San Joaquin River. Pipe is severely corroded with no closure devices. Uncertain if pipe penetrates through freeboard.

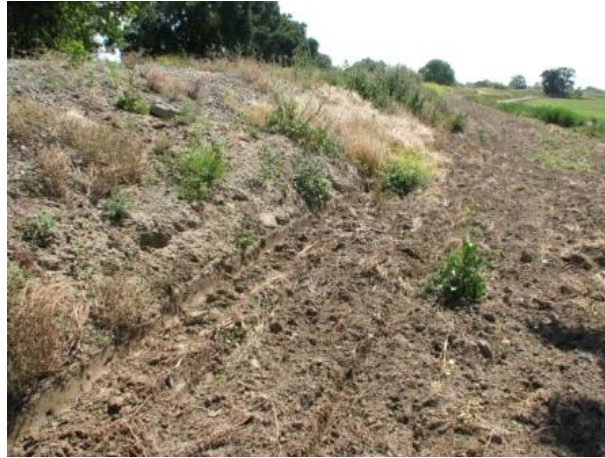
Levee Mile Report Line	20
Start Levee Mile	0.93
End Levee Mile	1.45
Location	Land Side
Category	Earthen Levee
Item	Encroachments

Discing of levee toe between slope and drainage ditch to manage vegetation.

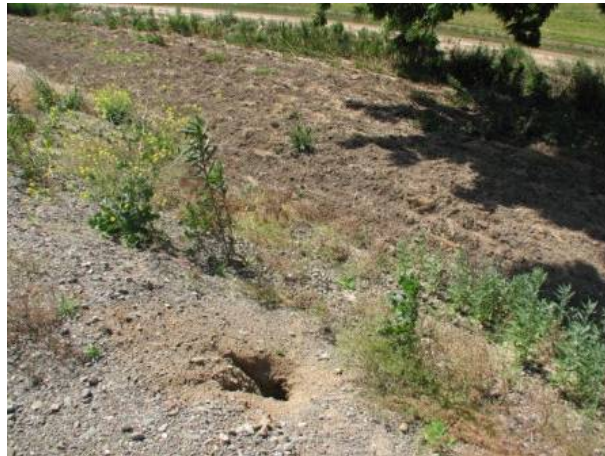
Levee Mile Report Line	22
Start Levee Mile	1.23
End Levee Mile	1.23
Location	Land Side
Category	Earthen Levee
Item	Animal Control

Large animal burrow at landside hinge point.

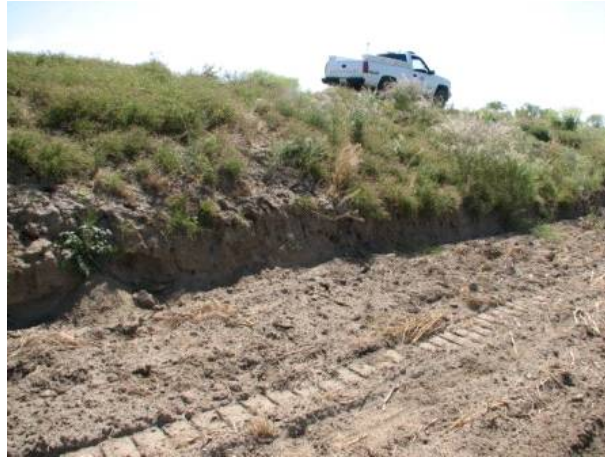
Discing at levee toe is cutting into levee slope.

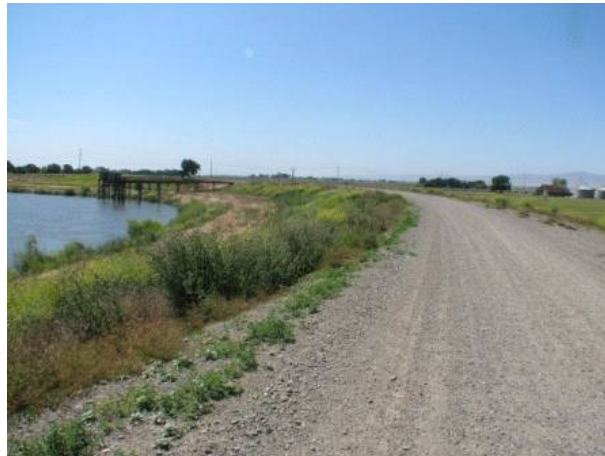
Levee Mile Report Line	8
Start Levee Mile	0.64
End Levee Mile	1.89
Location	Water Side
Category	Earthen Levee
Item	Vegetation

Annual grasses and weeds on levee slope.

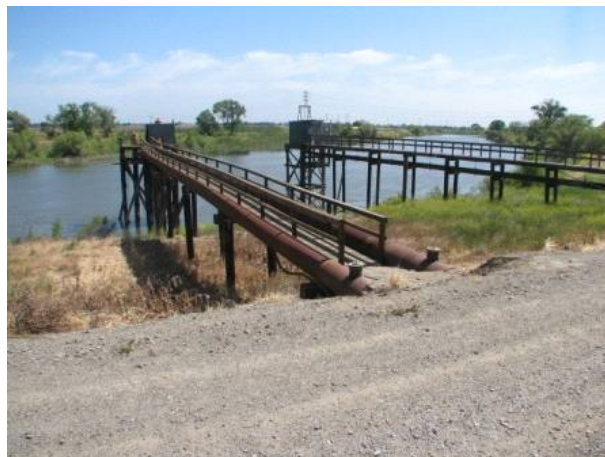
Levee Mile Report Line	9
Start Levee Mile	0.76
End Levee Mile	0.76
Location	Water Side
Category	Earthen Levee
Item	Encroachments

Irrigation intake pumps on San Joaquin River.

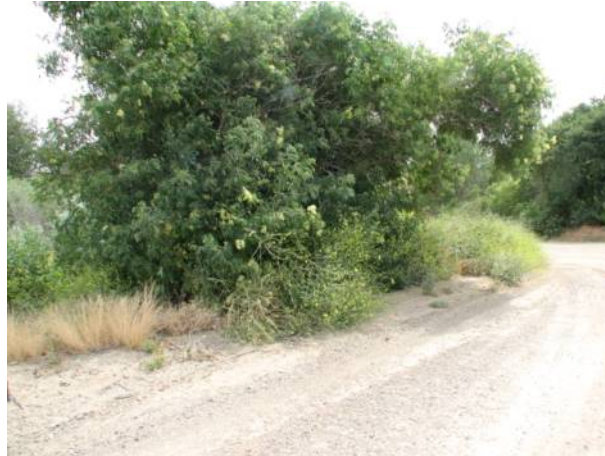
Levee Mile Report Line	12
Start Levee Mile	1.01
End Levee Mile	1.01
Location	Water Side
Category	Earthen Levee
Item	Vegetation
Dense vegetation on top 20' of waterside slope obstructs access and visibility.	
jpaasch_s_20100521_437.jpg

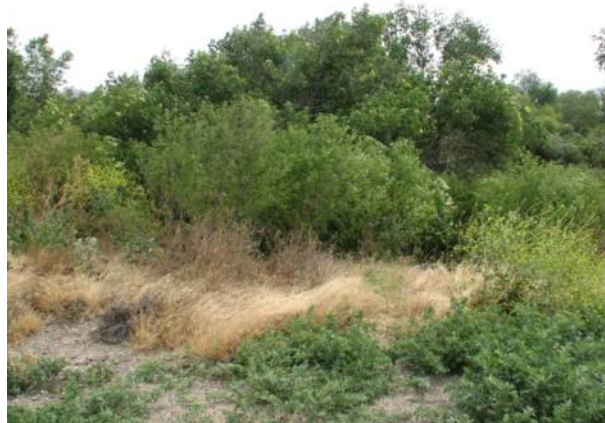
Levee Mile Report Line	15
Start Levee Mile	1.54
End Levee Mile	1.54
Location	Water Side
Category	Earthen Levee
Item	Vegetation
Vegetation on waterside slope obstructs access and visibility.	
jpaasch_s_20100521_438.jpg

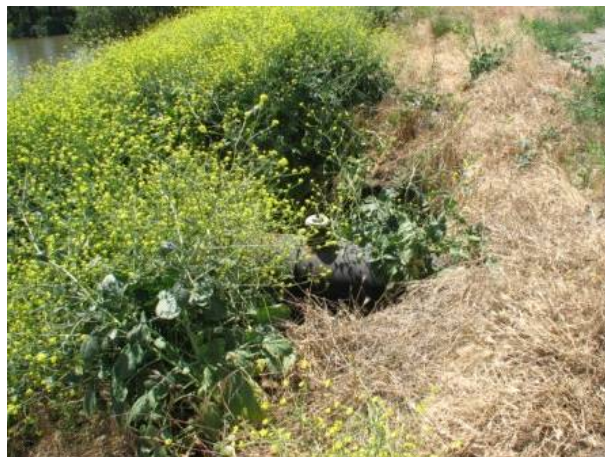
LMR No	Levee Mile		Category	Item	Location	Rating	Action/Comment	GPS Latitude/Longitude		Issue No.
	Start	End						Start	End	
17	1.67	1.67	Earthen Levee	Erosion / Bank Caving	WS	M	Schedule repair of erosion site prior to the next inspection. Inspector Comments: Erosion of levee slope due to pipe.	37.741126 ° -121.296329 °	37.741126 ° -121.296329 °	16 Y
18	1.77	1.80	Supplemental	DWR Erosion Survey	WS	U	Inspector Comments: 2009: Site immediately downstream of existing rip rap; there is a 20-ft berm remaining; however, berm will continue to erode, eventually erode into the levee profile; site # same as RM62.6, LM1.87; recommend annual assessment, per CES Evaluation 2008 Report [2009 SiteID:RD2095U2RM60.62]	37.740196 ° -121.297662 °	37.740196 ° -121.297662 °	1 Y
19	1.81	1.81	Earthen Levee	Erosion / Bank Caving	LS	C	Schedule repair of erosion site prior to the next inspection. Inspector Comments: Erosion site filled in and planted to stabilize slope.	37.739710 ° -121.297943 °	37.739710 ° -121.297943 °	18

Levee Mile Report Line	17
Start Levee Mile	1.67
End Levee Mile	1.67
Location	Water Side
Category	Earthen Levee
Item	Erosion / Bank Caving
Erosion around pipe penetration at levee slope.	
jpaasch_s_20100514_425.jpg

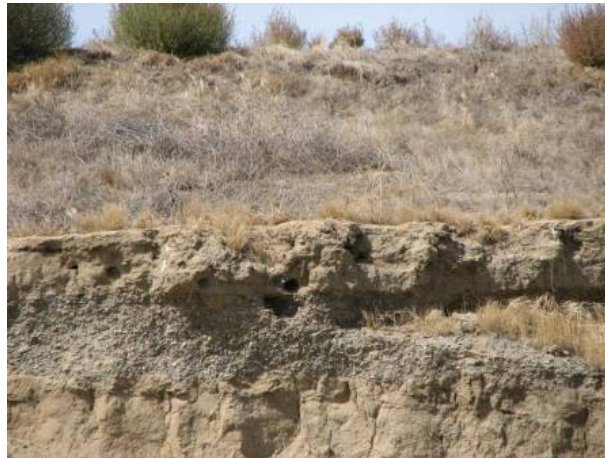
2009: Site immediately downstream of existing rip rap; there is a 20-ft berm remaining; however, berm will continue to erode, eventually erode into the levee profile; site # same as RM62.6,LM1.87; recommend annual assessment, per CES Evaluation 2008 Report [2009 SiteID:RD2095U2RM60.62]

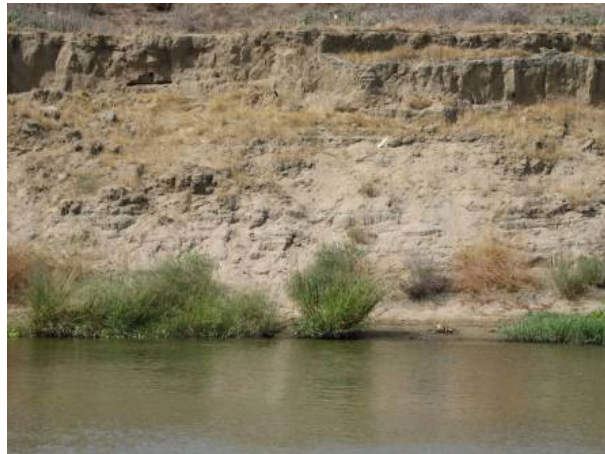
Levee Mile Report Line	18
Start Levee Mile	1.77
End Levee Mile	1.80
Location	Water Side
Category	Supplemental
Item	DWR Erosion Survey

2009: Site immediately downstream of existing rip rap; there is a 20-ft berm remaining; however, berm will continue to erode, eventually erode into the levee profile; site # same as RM62.6,LM1.87; recommend annual assessment, per CES Evaluation 2008 Report [2009 SiteID:RD2095U2RM60.62]

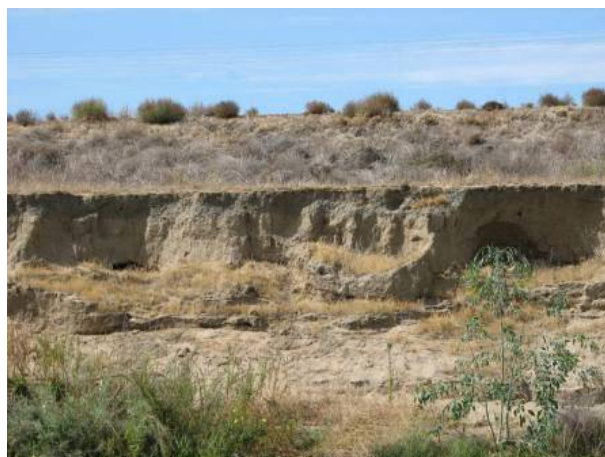
Levee Mile Report Line	18
Start Levee Mile	1.77
End Levee Mile	1.80
Location	Water Side
Category	Supplemental
Item	DWR Erosion Survey

2009: Site immediately downstream of existing rip rap; there is a 20-ft berm remaining; however, berm will continue to erode, eventually erode into the levee profile; site # same as RM62.6,LM1.87; recommend annual assessment, per CES Evaluation 2008 Report [2009 SiteID:RD2095U2RM60.62]

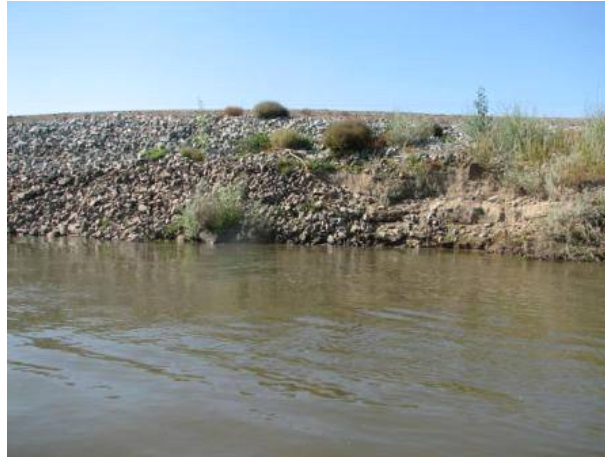
2009: No major change observed; sloughing of the rip rap above toe; erosion begins immediately downstream of existing rip rap; roughly 15-ft berm remains; however, it will continue to erode and eventually intrude into the levee profile if left untreated [2009 SiteID:RD2095U2RM60.69]

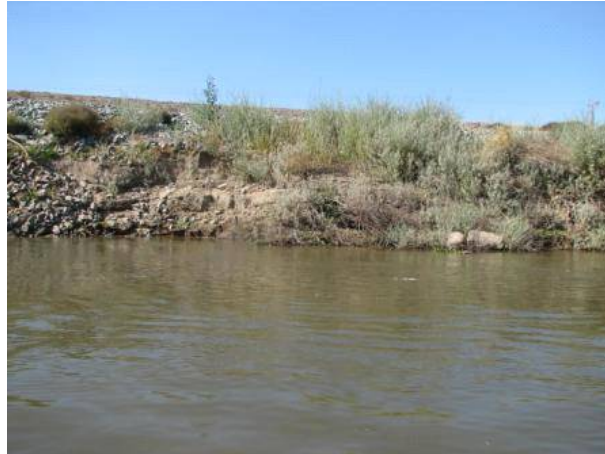
Levee Mile Report Line	20
Start Levee Mile	1.85
End Levee Mile	1.89
Location	Water Side
Category	Supplemental
Item	DWR Erosion Survey

2009: No major change observed; sloughing of the rip rap above toe; erosion begins immediately downstream of existing rip rap; roughly 15-ft berm remains; however, it will continue to erode and eventually intrude into the levee profile if left untreated [2009 SiteID:RD2095U2RM60.69]

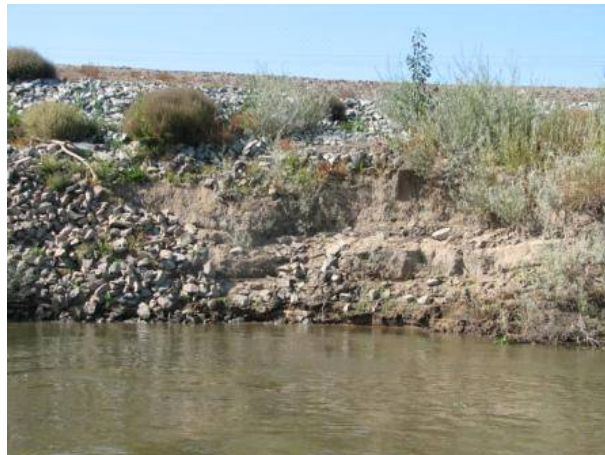
Levee Mile Report Line	20
Start Levee Mile	1.85
End Levee Mile	1.89
Location	Water Side
Category	Supplemental
Item	DWR Erosion Survey

2009: No major change observed; sloughing of the rip rap above toe; erosion begins immediately downstream of existing rip rap; roughly 15-ft berm remains; however, it will continue to erode and eventually intrude into the levee profile if left untreated [2009 SiteID:RD2095U2RM60.69]

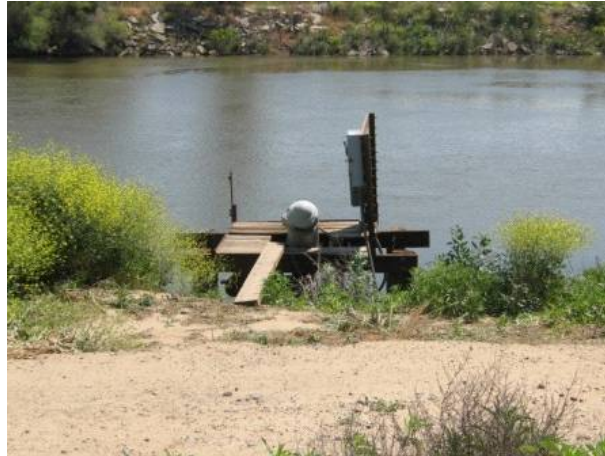
Levee Mile Report Line	22
Start Levee Mile	2.10
End Levee Mile	2.10
Location	Water Side
Category	Earthen Levee
Item	Encroachments
Intake on San Joaquin River. Pipe penetrates levee freeboard.	
jpaasch_s_20100514_426.jpg

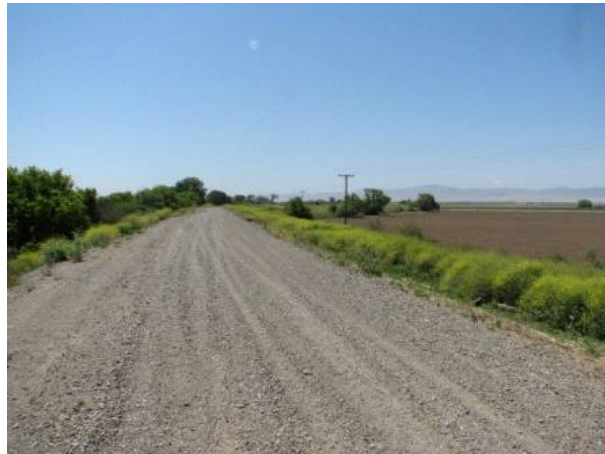
Levee Mile Report Line	25
Start Levee Mile	2.15
End Levee Mile	2.80
Location	Land Side
Category	Earthen Levee
Item	Vegetation
Annual grasses and weeds on levee slopes.	
jpaasch_s_20100514_427.jpg

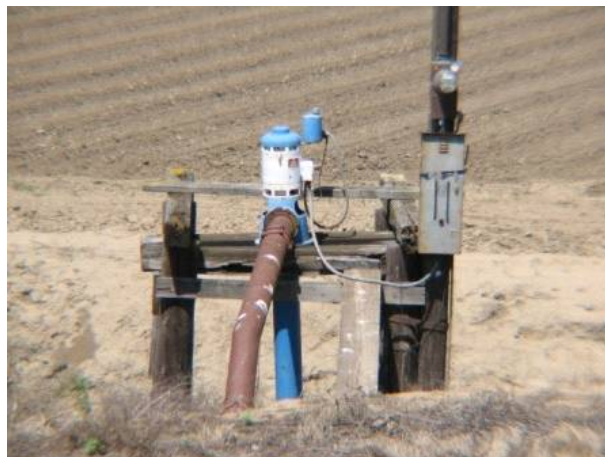
Levee Mile Report Line	27
Start Levee Mile	2.39
End Levee Mile	2.39
Location	Crown
Category	Earthen Levee
Item	Encroachments
Drainage discharge into San Joaquin River. Pipe appears to penetrate below levee freeboard. No closure devices found. Elevated at pump connection.	
jpaasch_s_20100514_428.jpg

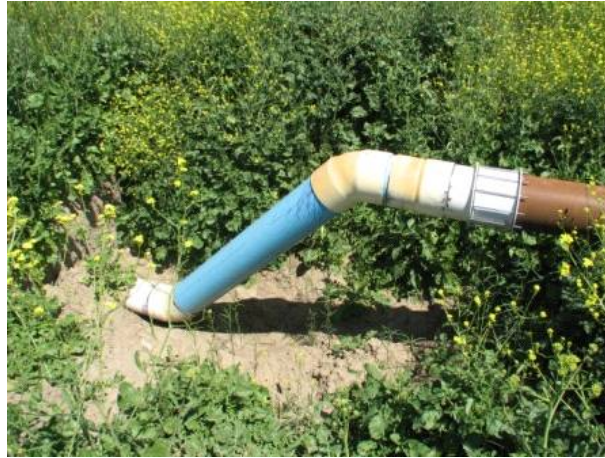
Plastic pipe connection made on landside.
